# Moisture Problems in Manufactured Housing

*Manufactured homes are affordable to many. A study points the way to making them healthy by dealing with moisture problems.*

by Neil Moyer

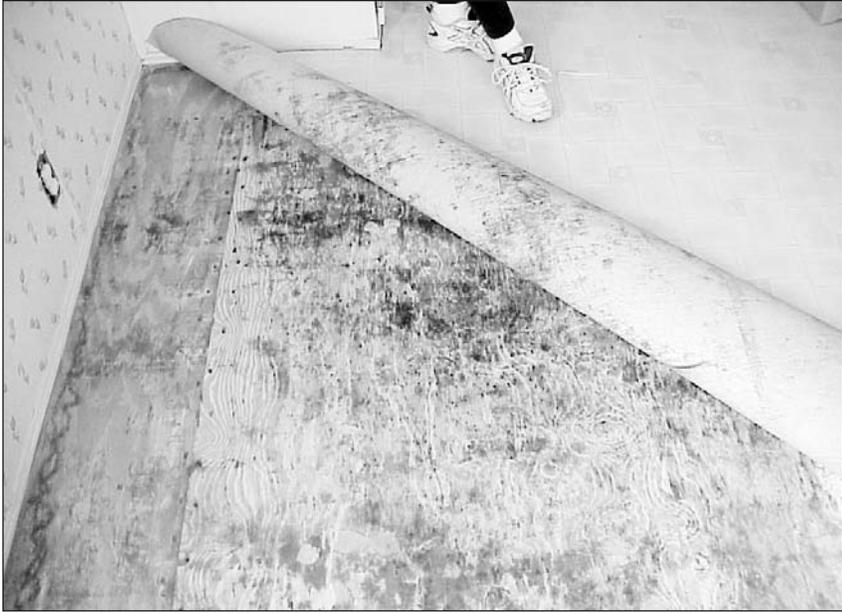
Vinyl flooring in manufactured homes can cause moisture damage, since the low moisture permeability of vinyl can lead to condensation.
