# After the Flood

*Since people continue to build—and rebuild—their houses in flood prone areas, finding the materials that hold up best after flooding could save energy and money and keep tons of material out of landfills.*

by Sherry Livengood  
and Heshmat Aglan

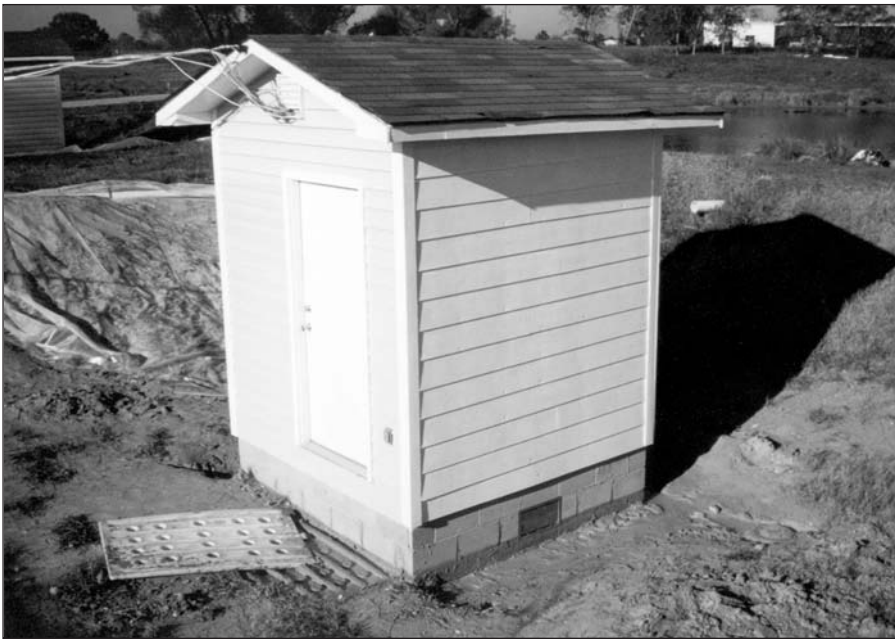
Because reproducing flood conditions in actual houses was not practical, we made small prototype test structures.
